NASA Technical Memorandum 78796

THE EFFECT OF IMPACT DAMAGE AND CIRCULAR HOLES ON THE COMPRESSIVE STRENGTH OF A GRAPHITE-EPOXY LAMINATE

James H. Starnes, Jr., Marvin D. Rhodes and
Jerry G. Williams

October 1978

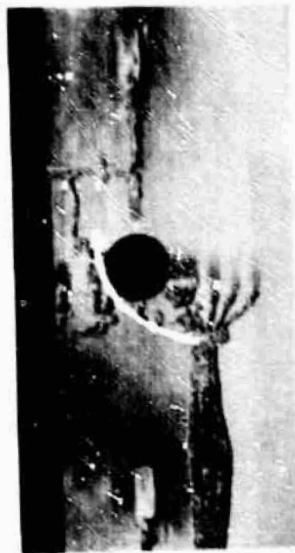
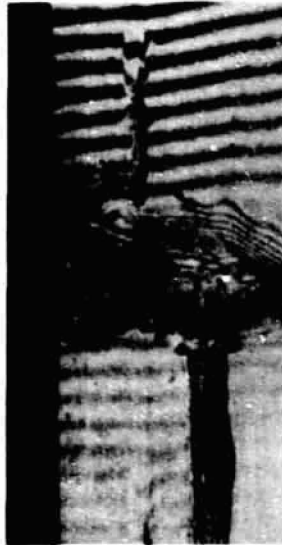
(a) 92.8 percent of ultimate load. No delamination.

(b) 95.4 percent of ultimate load. Delamination to left of hole.

(c) 95.9 percent of ultimate load. Additional delamination to right of hole.

(d) 98.1 percent of ultimate load. Delamination growth.

Figure 12. - Local delamination in hole region and propagation to failure. 1.91 cm diameter hole.

(e) Failed specimen.

A series of photographs of the propagating moire-fringe patterns for a specimen with a 1.91-cm-diameter hole is shown in figure 12 for increasing values of applied load. Figure 12a shows a photograph of the specimen loaded to 92.8 percent of the ultimate failure load and the absence of moire fringes indicates there are no out-of-plane deformations evident. At a slightly higher load (fig. 12b) a small out-of-plane deformation region developed at the left edge of the hole. These results, along with the strain gage results in the hole region and direct visual observations, indicate that a local delamination has developed near the hole. A second local delamination developed at the right edge of the hole (fig. 12c) after another slight increase in applied load. These delaminated regions continued to propagate, first in short discrete increments (fig. 12d), and then rapidly at the failure load (fig. 12e). The failed specimen shown in figure 12e was cut along an axial line passing through the center of the hole. A photograph of the cross section of the specimen in figure 13 shows many local delaminations through the thickness of the laminate. These delaminations extend completely across the specimen width but only extend a short distance in the axial direction.

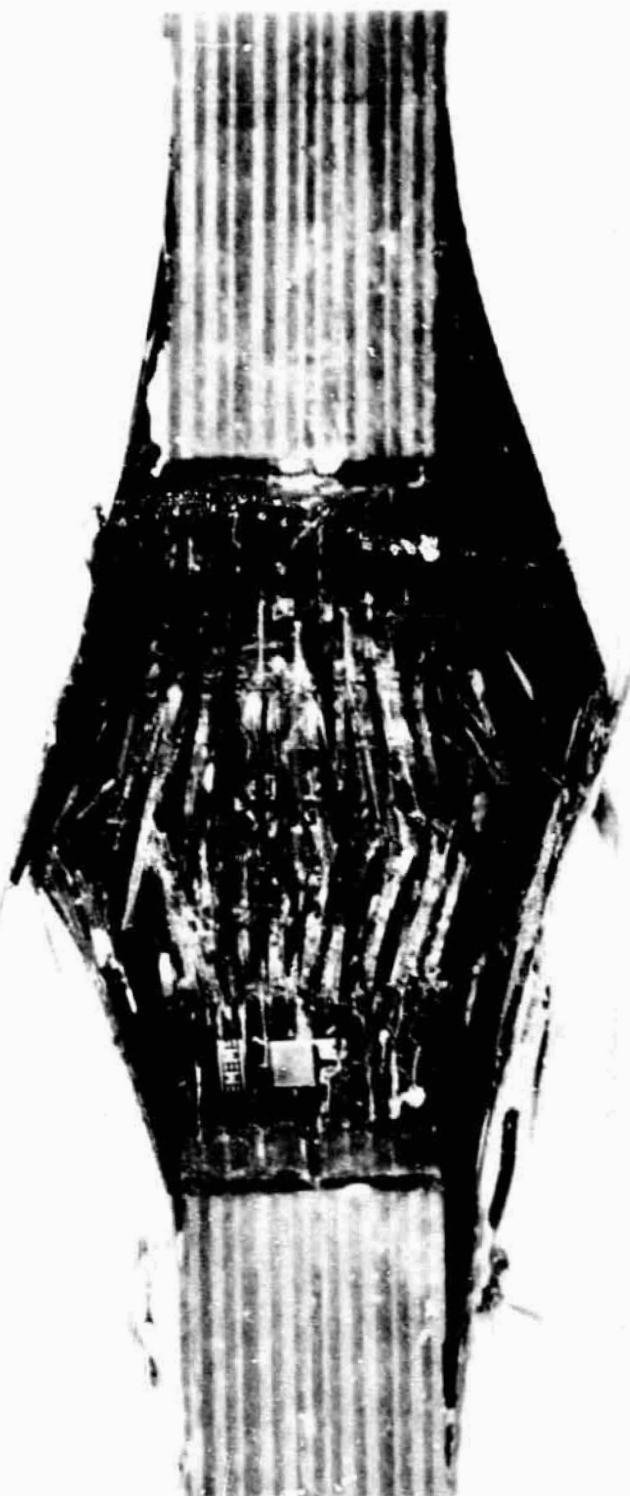
Figure 13. - Cross section of a failed specimen with a 1.91 cm diameter hole.
